**Lessons Learned from the
Project Meeting in Ghent & Liège (Belgium)**
on September 28/29, 2015

Project acronym: BiTiBi

Project title: Easy and energy efficient from door to door Bike+Train+Bike

Lessons learned from the project meeting in Ghent and Liège (Belgium) and study tour on September 28 and 29, 2015, easy to read-relevant report.

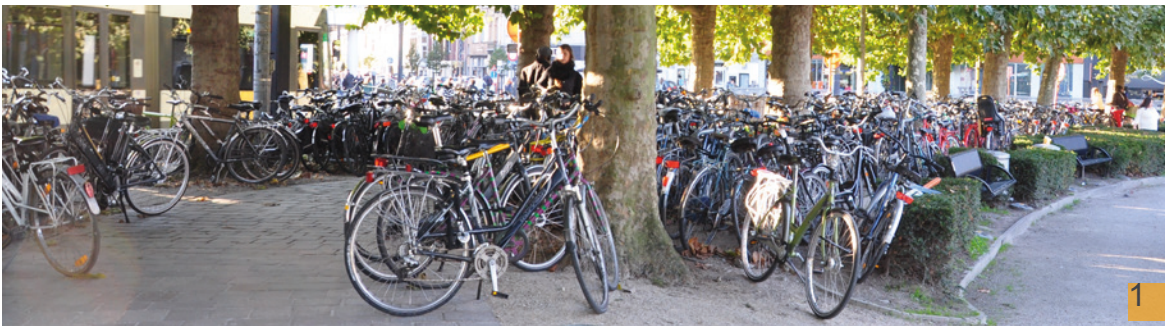
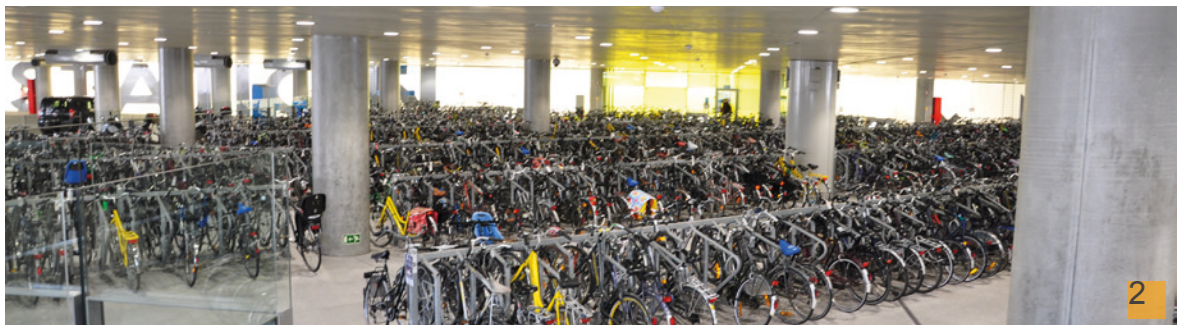
• Impressive renovations of the train station are currently underway, with plans for **11,000 bike parking spaces**. The temporary situation (picture 1) may seem a little confusing, however once complete, the new bike parking facilities under the new station will impress users with its level of safety, easy to use racks, and clear overview with open sight-lines.

• The racks in the new **covered bike parking** facility are very well used (picture 2). Given the high demand, especially in this temporary situation, it is remarkable that the space between racks is so wide, especially when compared to Dutch bike parking facilities. Two-tier bike racks may be an appropriate solution, however it is important to keep in mind that this solution would block sight-lines, therefore decreasing the feeling of user-safety.

• In the temporary bike parking solution, there is a significant shortage of parking spaces (note the square in front with many bikes). While construction continues at the station, **temporary bike parking spaces** have been introduced on public roads. A better accessible and more attractive bike parking behind the station would be of added help

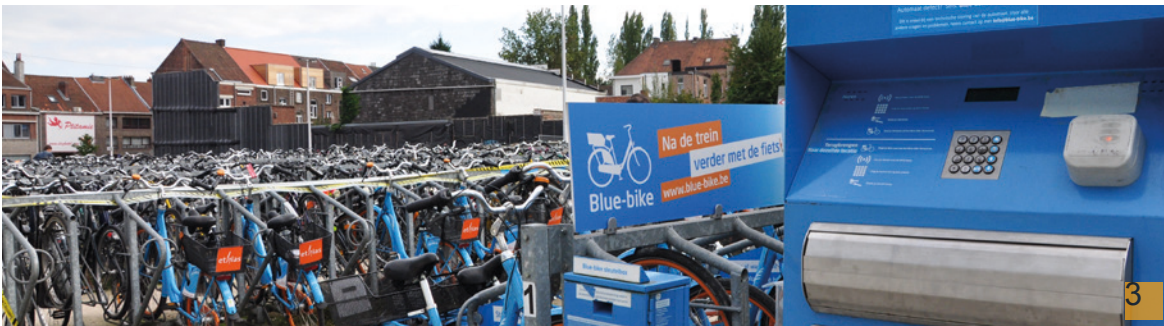
• Located at a central train station, it is only natural that there is a high demand for bike rentals at this site (picture 3). Short term rental bikes are available through automatic **Blue-bike rental locations** and by personnel at the 'Fietspunt' (run by social enterprise Max Mobiel). The cooperation between Blue-Bike and 'Fietspunt' is useful as it offers the chance to rent a bike at a staffed location.

spunt' could be better as it should be easier to find these valuable services after exiting the platforms.

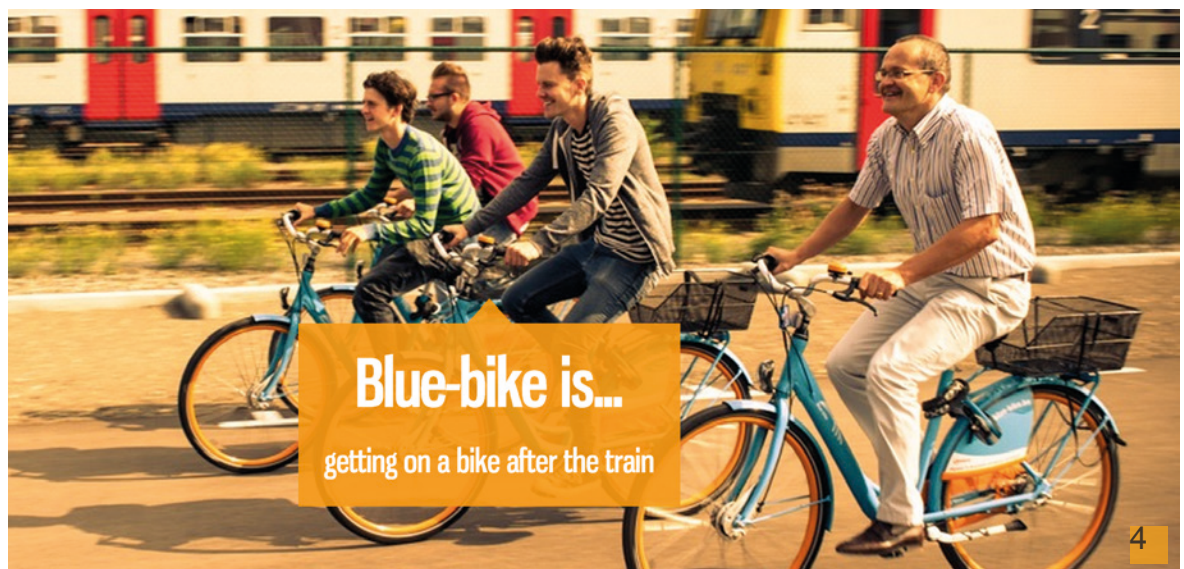
- Blue Mobility and the easily recognizable Blue-bikes have developed a strong visual identity, making use of **photographs of real users in ad campaigns** (picture 4).

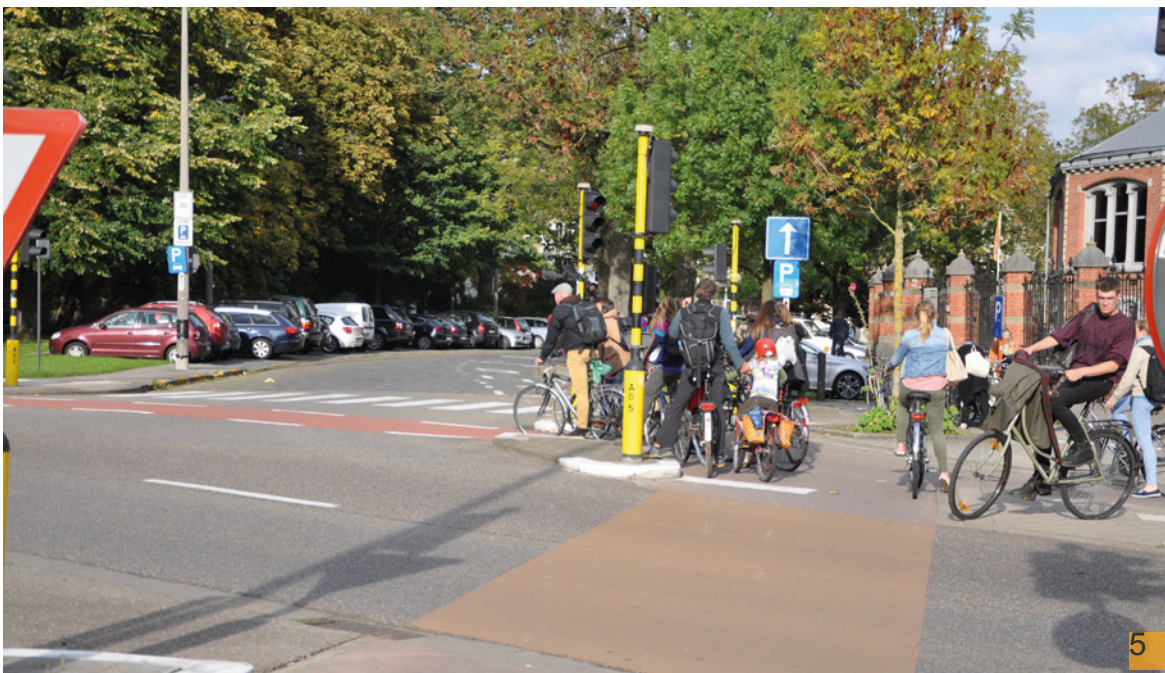
• Ghent is a true **cycling city with many cyclists**. Especially in comparison to Liège, the city of Ghent has a lot of separated cycle lanes (picture 7), some bike streets (picture 6) and a large network of cycling infrastructure (pictures 5, 8 & 9). However, the cycling infrastructure provided is not always appropriate given the high demand and potential for further growth.

• Limiting the available space to make a pass, the often narrow cycle lanes prove to be inconvenient for cyclists travelling at all speeds. Although in Ghent space for road traffic has sometimes been limited in favour of cycle roads, this is not done on the same scale as in Dutch cities. Moreover, at crucial intersections cycle infrastructure is sometimes lacking, combining all the traffic and creating unsafe situations. And on many larger roads there is no

• Sometimes there is very little space between parked cars and the cycle lane, creating dangerous situations when drivers get out of their car, swinging their door into the cycle lane. On routes where demand for car parking is low (e.g. Sint-Denijslaan) parking spaces on one side could be removed in favour of extra (possibly separated) cycle lanes. Even where demand for car parking is high, there is often enough room for car parking spaces to be moved (e.g. to an area between the trees as on Sint-Denijslaan) in favour of cycle infrastructure.

• Cycle routes have no direct link with the station (picture 10: ramp of a bike parking) and are more focused on the neighbourhoods. Wayfinding and signage for cyclist is not always available, which could make navigating difficult.

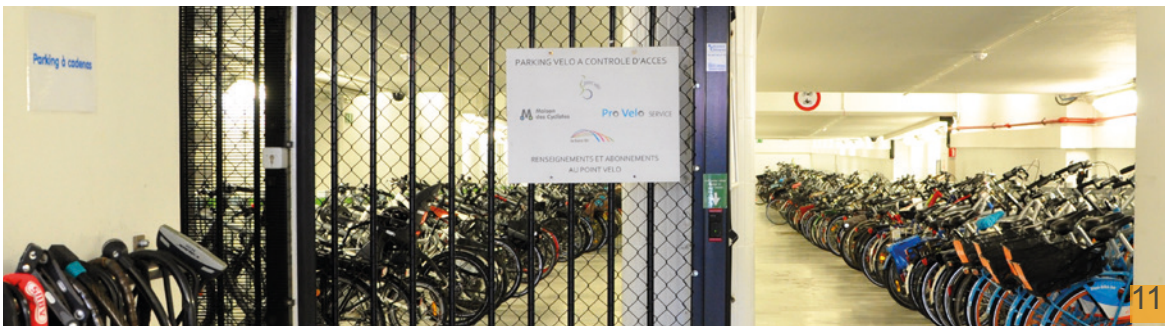
• The impressive main train station of Liège is designed by world renowned architect Santiago Calatrava and features **two bike parking facilities** (picture 12), one inside (picture 11) the station while the other outside (picture 13). The indoor parking facilities are especially difficult to find as **signage is lacking**. This has to do with the general design principles of the station as even the basic services such as departures and platforms details are difficult to find.

• The main parking is indoor and of good quality with a capacity of around 180 bikes. It has one entrance

but consists of **two separate sections** inside, one free of charge and a second for **members-only** (35 bikes, monthly and yearly subscriptions). Both sections are checked twice a day and two video cameras film the place constantly.

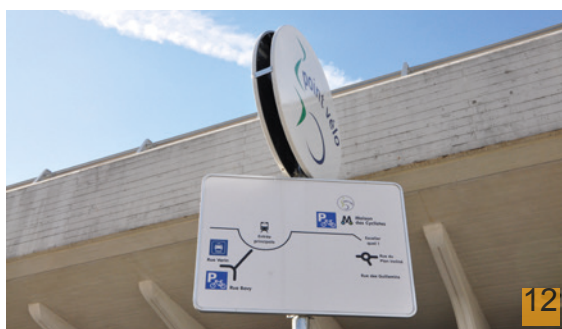
• The other much smaller indoor parking is located at the rear side of the station but is almost impossible to locate and not very well used. However, it has fairly good access to the platforms.

• There is very limited **outdoor cycle parking** space with one location with covered cycle racks in front of the station.

• Cycling is not as popular as in Ghent and the capacity seems to be just sufficient for the current demand. In order to accommodate growth in commuters coming to the station by bike, an expansion of cycle parkings in a balanced way is recommended. The local government could play a bigger role in co-financing new bike parking facilities (as is done in Holland where often around one third of the costs are paid for by the municipality).

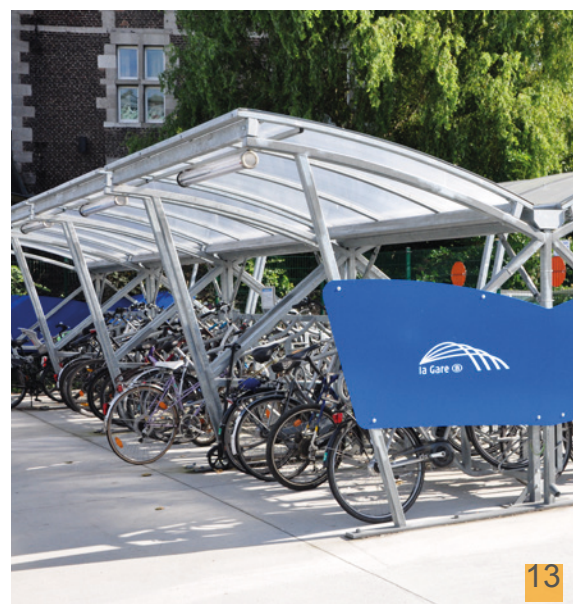
• The Blue-bikes (picture 14) are available through an **automatic Blue-bike rental location** and **by personnel** at the 'Maison des Cyclistes' (run by cycle promotion organisation ProVelo). It could be interesting to develop more Blue-bike locations in Wallonia to improve the regional network. As in Ghent, the cooperation between Blue-bike and the 'Maison des Cyclistes' is useful for the clients as they have a choice here between an automatic and a staffed rental location.

• The '**Maison des Cyclistes**' also rents out other rental bikes through a municipal scheme, provides advice, self service maintenance facilities and a mobile bike repair service (picture 15), and checks and cleans the bike parkings at the station. These activities show the added value of their presence at the station for people cycling to and from the station.

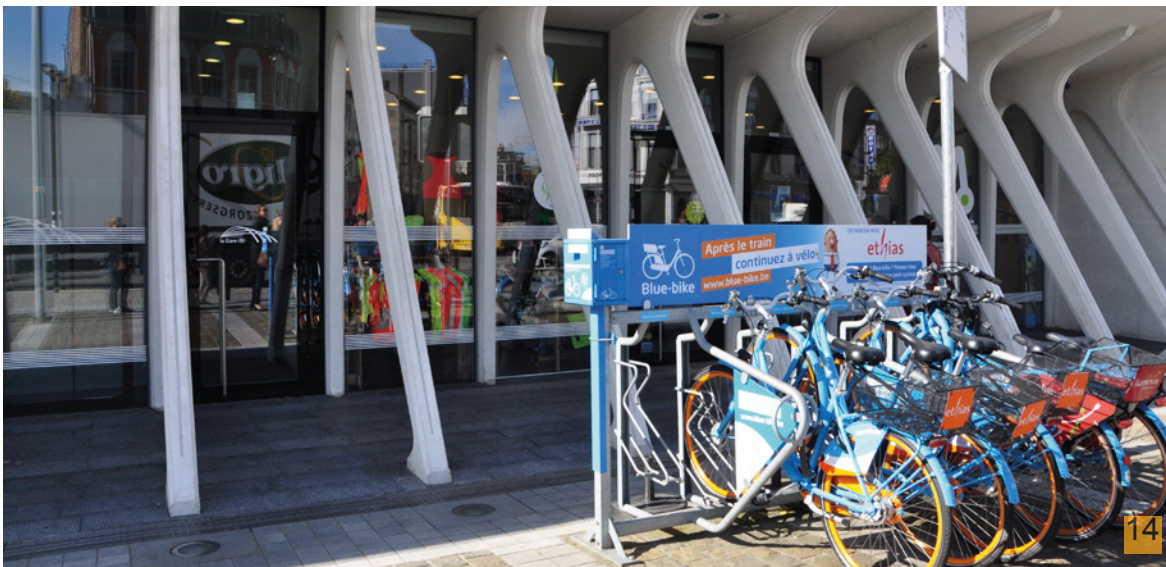
• The 'Maison des Cyclistes' and Blue-bikes might be **difficult to find**, signage should be improved.

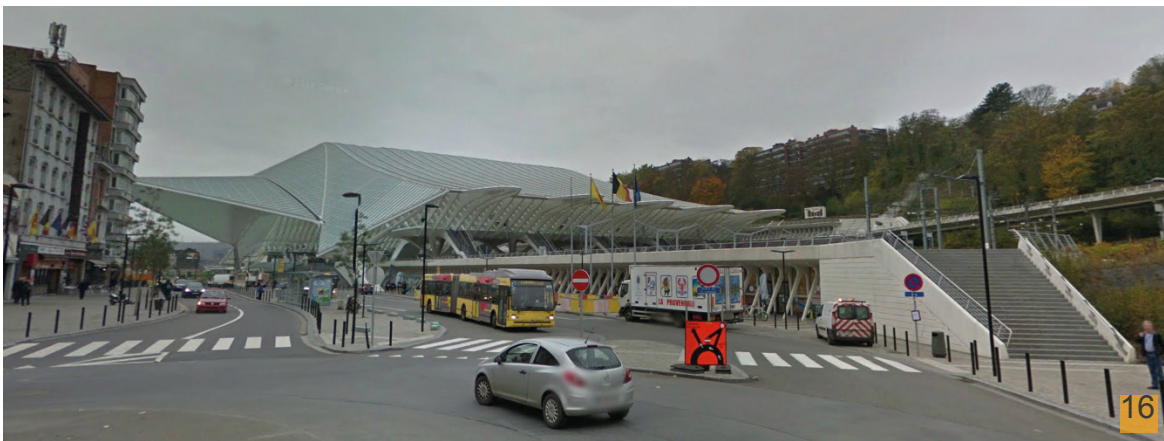
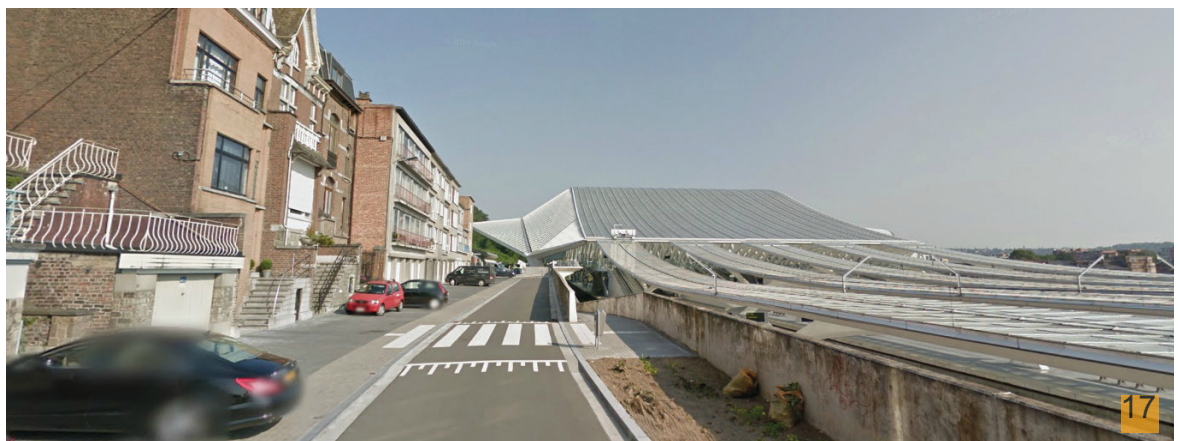
• It seems that cyclists **are not treated well** immediately around the station. **Cycle routes are not continuous**, forcing people traveling by bike to behave like a pedestrian (on the sidewalk) or like a car (on the main road). In this situation, a cycle route could provide additional security. A cycle route that passes the station could make the 'Maison des Cyclistes' and cycle parking facilities easier and safer for people traveling by bike approaching from Rue Paradis and Place des Guillemins (in front of the station, picture 16). The local government could play a bigger role in providing safer routes towards the station.

across the river will be built). In general, cycle routes from the station towards the neighbourhoods are not attractive because they are interrupted too many times by main roads without any protection for cyclists (picture 17, back of the station). The sign 'cycle path' is not consequently used across town.

• The quality of the surface of the roads and bicycle routes is often insufficient. There is a high contrast in maintenance for public space and (cycle) roads.

• **Signage for cyclists is lacking**, at least the route from the station to the centre should be signposted. Expansion to a general wayfinding system for the whole city and region is preferable.
